Manhole Inspection Summary

Manhole # S21GG_025MH

Insp Date: **6/15/07 7:59 AM**

Location Address: **1818 PRESSTMAN ST**

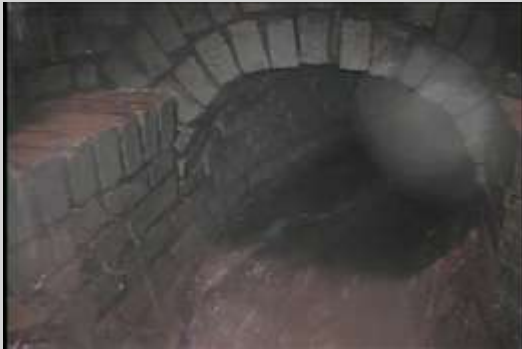
12 O'Clock Outflow

24 in. Circular Gravity Sewer
Pipe Out @ 12 O'Clock

Pipe Height: **24** (in.) Rod and Bar (Angled)
Pipe Material: **Clay** ☐ Pipe Lined
Invert Depth: **19.98** (ft.) Flow Characteristics: **Slow**
Deposits: ☒ None ☐ Mud ☐ Sludge ☐ Debris ☐ Grease
Silt Depth: (in.) Deposits Extent:
Infiltration: **None** Pipe Seal Cond: **Sound**

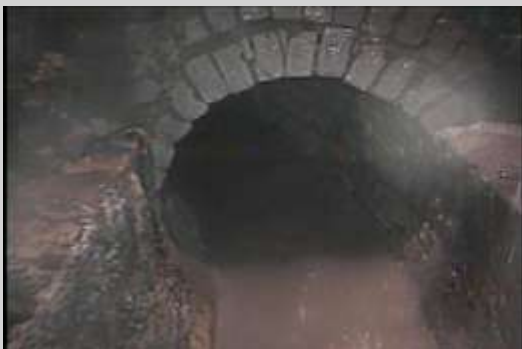
5 O'Clock Inflow

24 in. Circular Gravity Sewer
Pipe In @ 5 O'Clock

Pipe Height: **24** (in.) Rod and Bar (Angled)
Pipe Material: **Clay** ☐ Pipe Lined
Invert Depth: **19.72** (ft.) Flow Characteristics: **Slow**
Deposits: ☒ None ☐ Mud ☐ Sludge ☐ Debris ☐ Grease
Silt Depth: (in.) Deposits Extent:
Infiltration: **None** Pipe Seal Cond: **Sound**
